**Docket No. 217 – Development and Management Plan Inspection**

**Date:** March 12, 2004

**Location:** Norwalk Substation Expansion

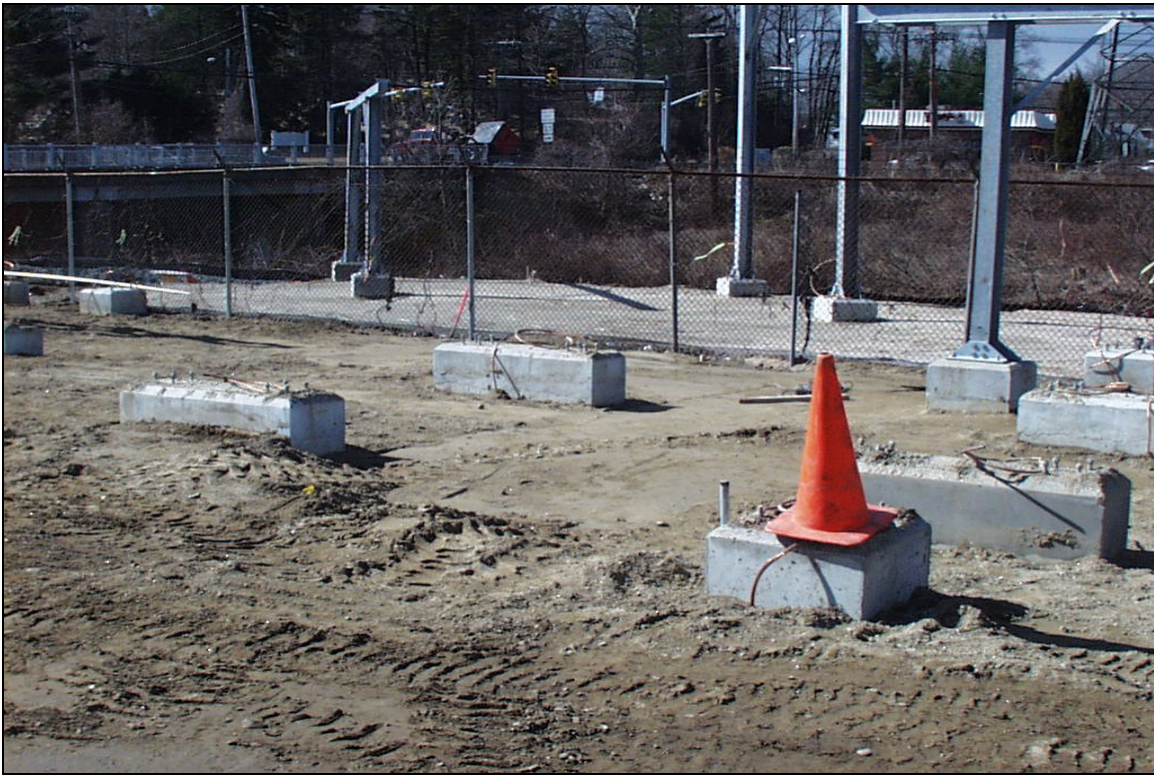
THE FOUNDATION CONSTRUCTION AREAS NEAR THE EDGE OF THE FENCED YARD HAVE BEEN BACKFILLED FOR THE MOST PART. 3/12/04

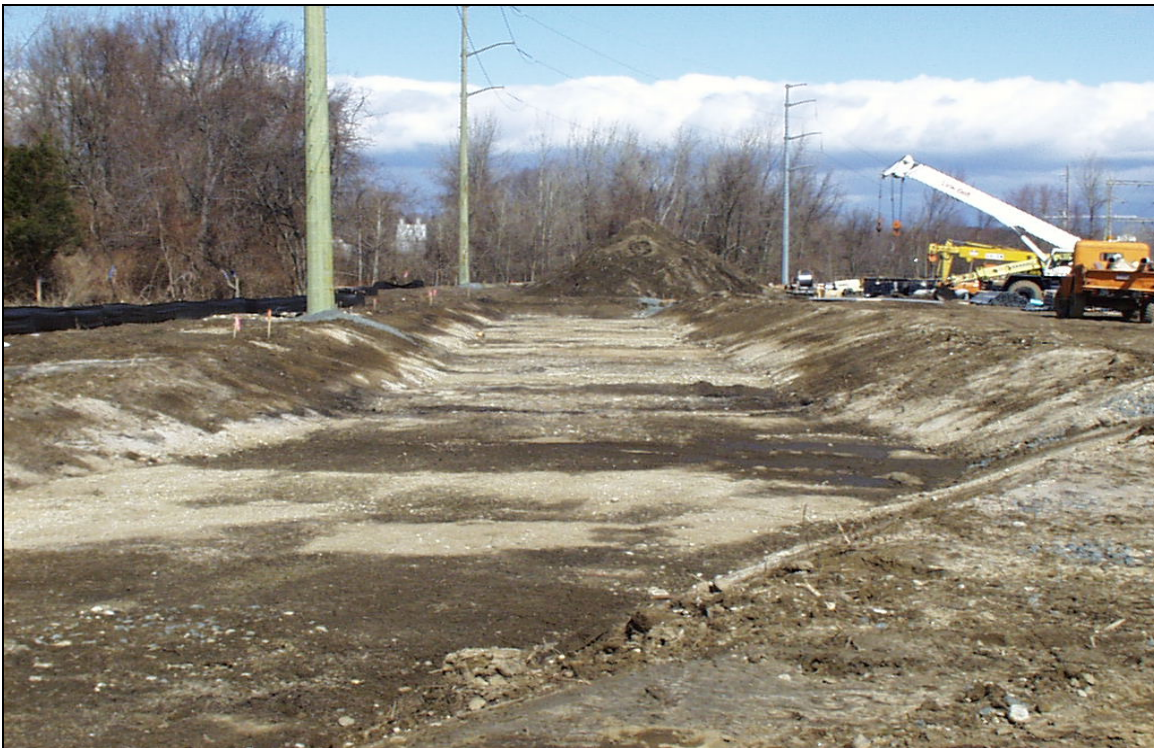
VIEW OF THE DRY SEDIMENT BASIN. THE DEWATERING ACTIVITIES ARE COMPLETE AND THE BASIN IS NOT RECEIVING ANY RUNOFF. 3/12/04

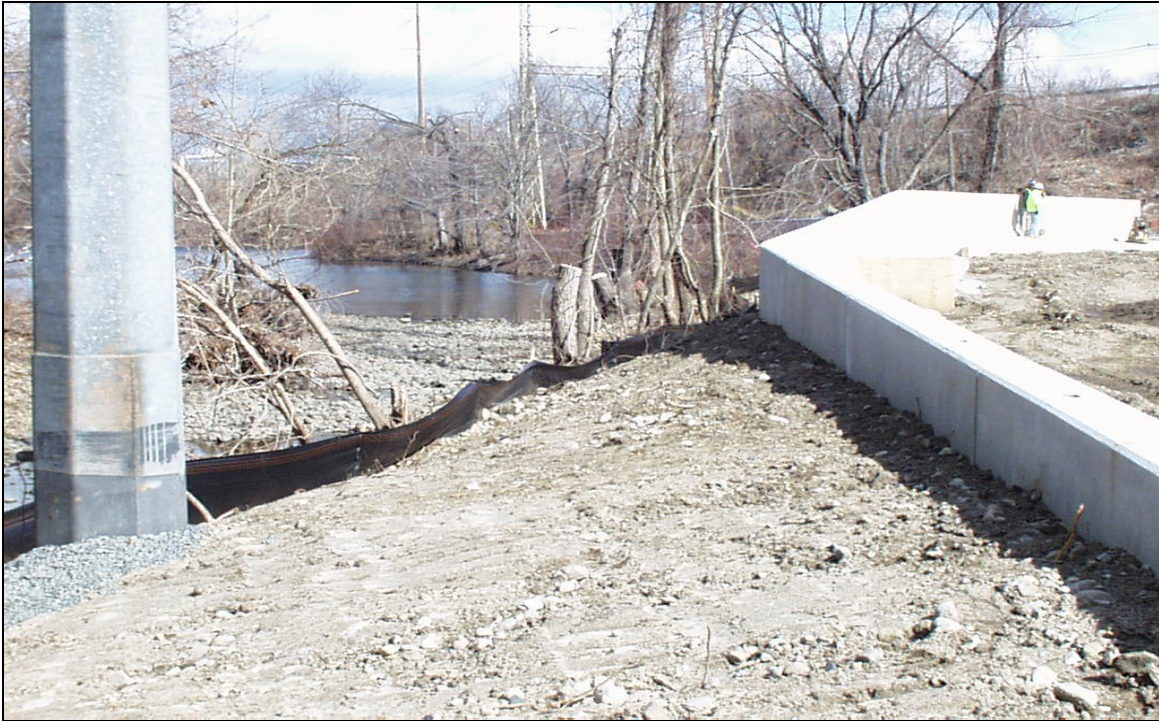
THE RIPRAP PLACED AT THE BASE OF THE WALL HAS BEEN BACKFILLED. SILT FENCE IS STILL WELL IN PLACE BUT TEMPORARY VEGETATIVE STABILIZATION SHOULD BE CONSIDERED 3/12/04

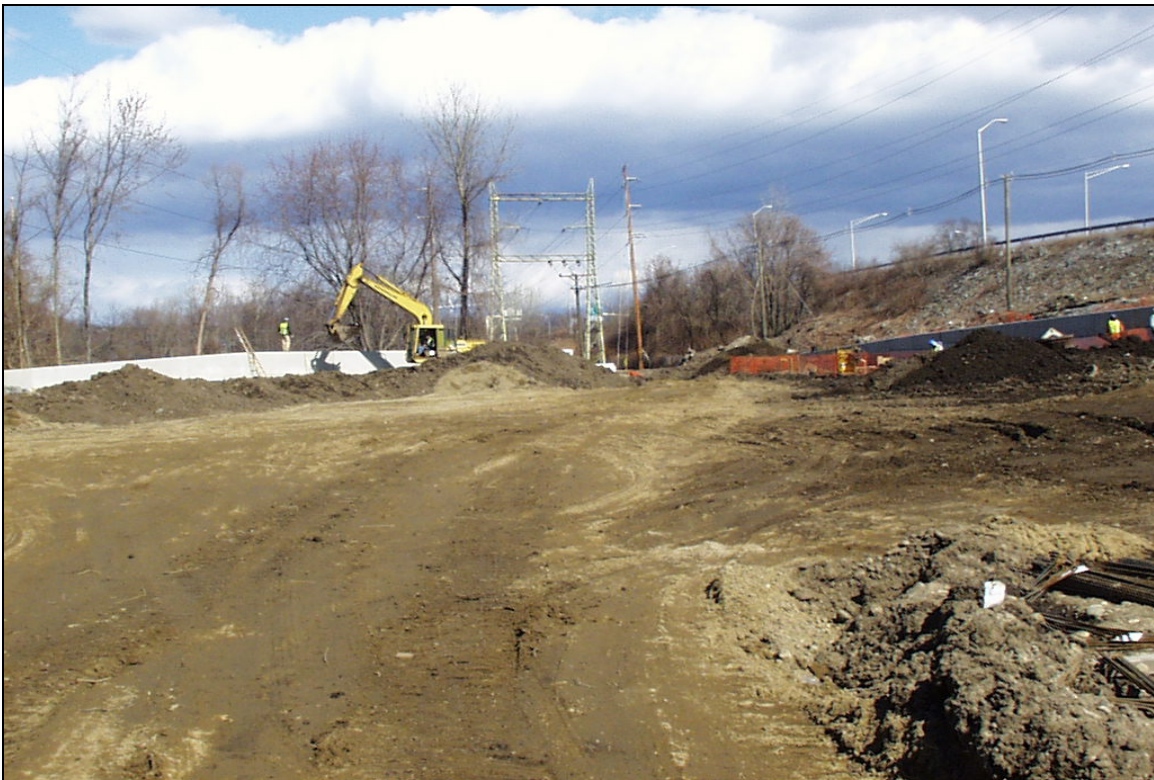
OVERALL VIEW OF THE SITE WITH THE TWO MAIN RETAINING WALLS. 3/12/04

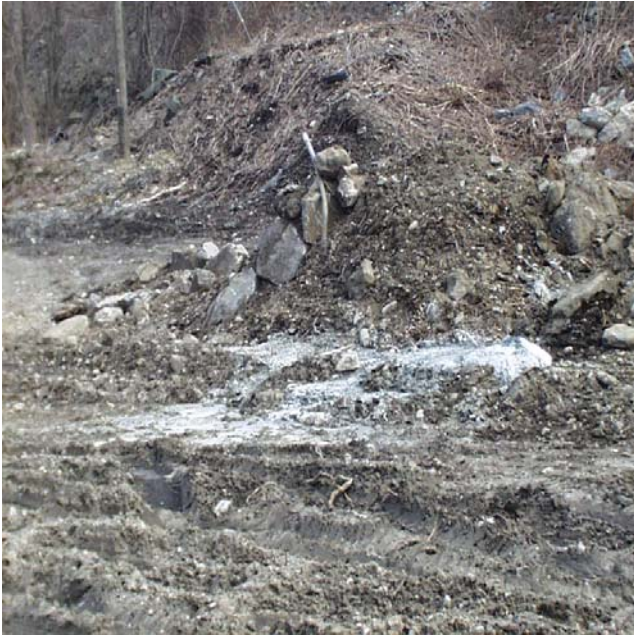
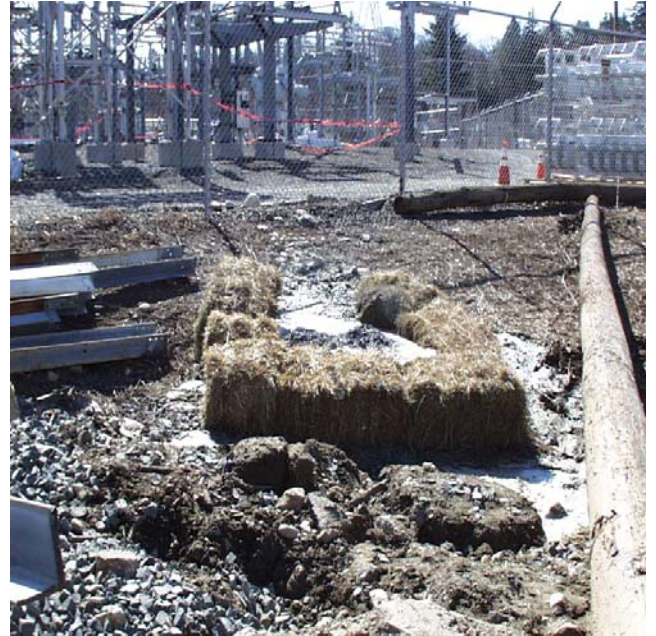
A CONCRETE WASHOUT AREA HAS BEEN SETUP AND IS BEING UTILIZED, HOWEVER ONE WASHOUT WAS NOTED IN ANOTHER LOCATION. 3/12/04

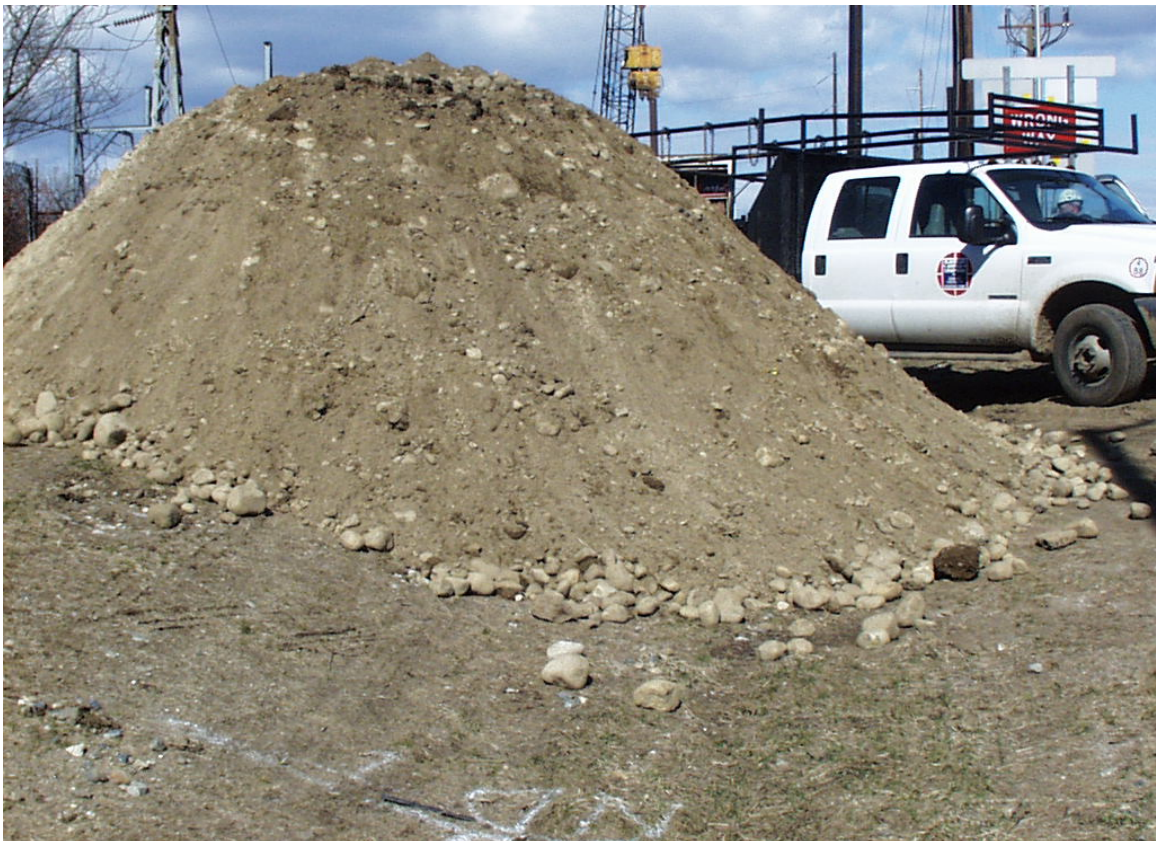
VIEW OF STOCKPILE FROM THE EXCAVATION ALONG THE ROUTE 7 RAMP.  
HAYBALES SHOULD BE PLACED HERE TO PREVENT RUN-OFF TO THE ROAD.  
3/12/04

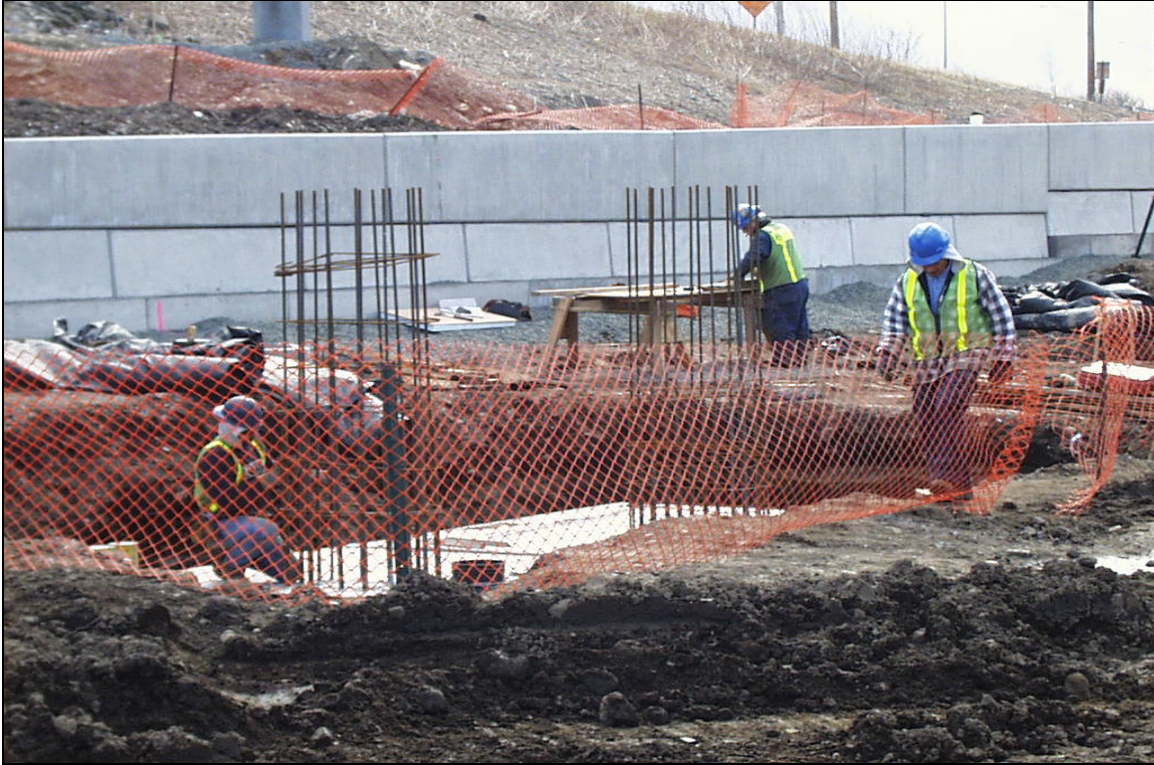
EXCAVATIONS FOR CONCRETE FOUNDATIONS OF TOWERS. THE AREAS ARE  
WELL CONTROLLED. 3/12/04

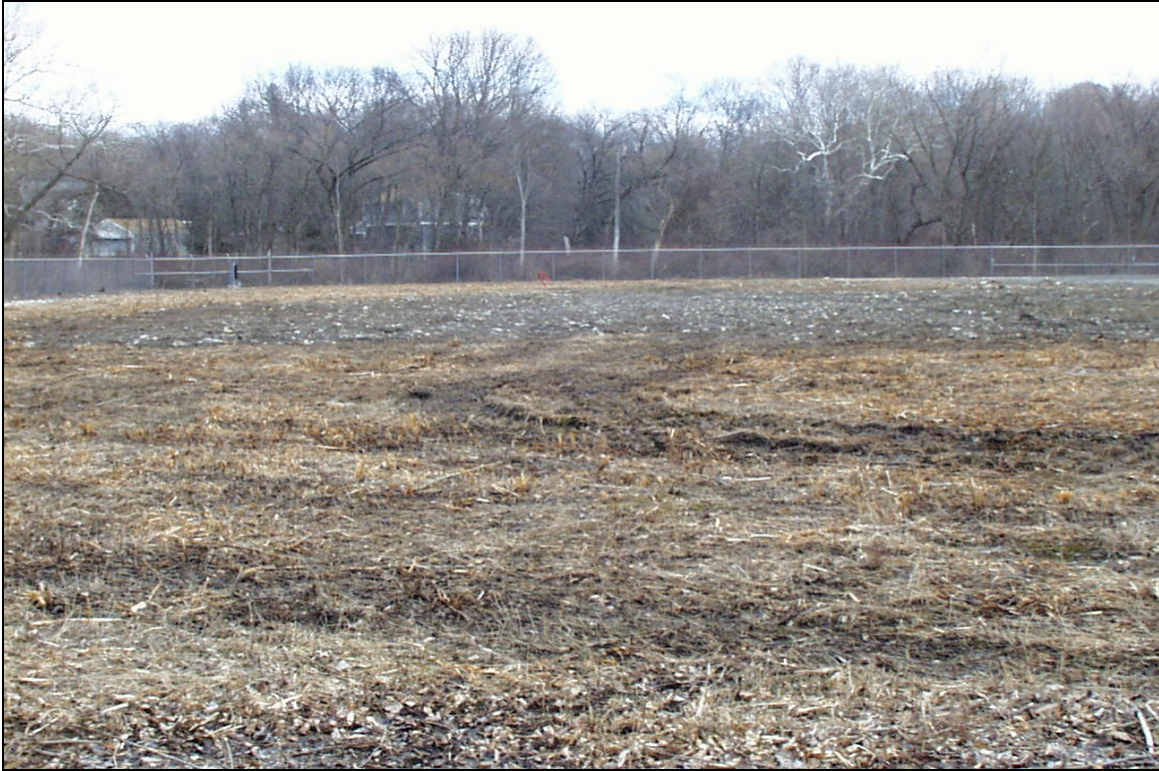
VIEW OF THE YARD AT BETHEL PLUMTREE SUBSTATION. THE AREA WITHIN THE YARD HAS BEEN CLEARED OF BRUSH. NO OTHER ACTIVITIES HAVE OCCURRED.  
3/12/04
